Name of Dam: Lake Land'or Dam

Location: Caroline County, Commonwealth of Virginia

Inventory Number: VA 03309

PHASE I INSPECTION REPORT NATIONAL DAM SAFETY PROGRAM

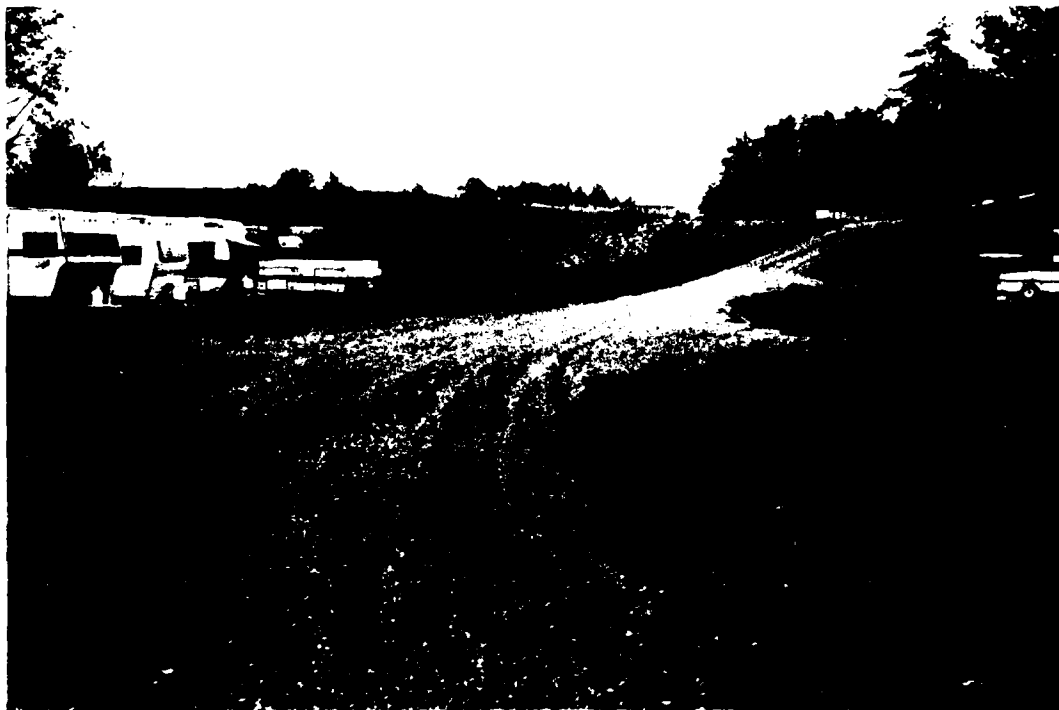
**PHOTO 2. Camper Storage and Campground Immediately
Downstream of Spillway**

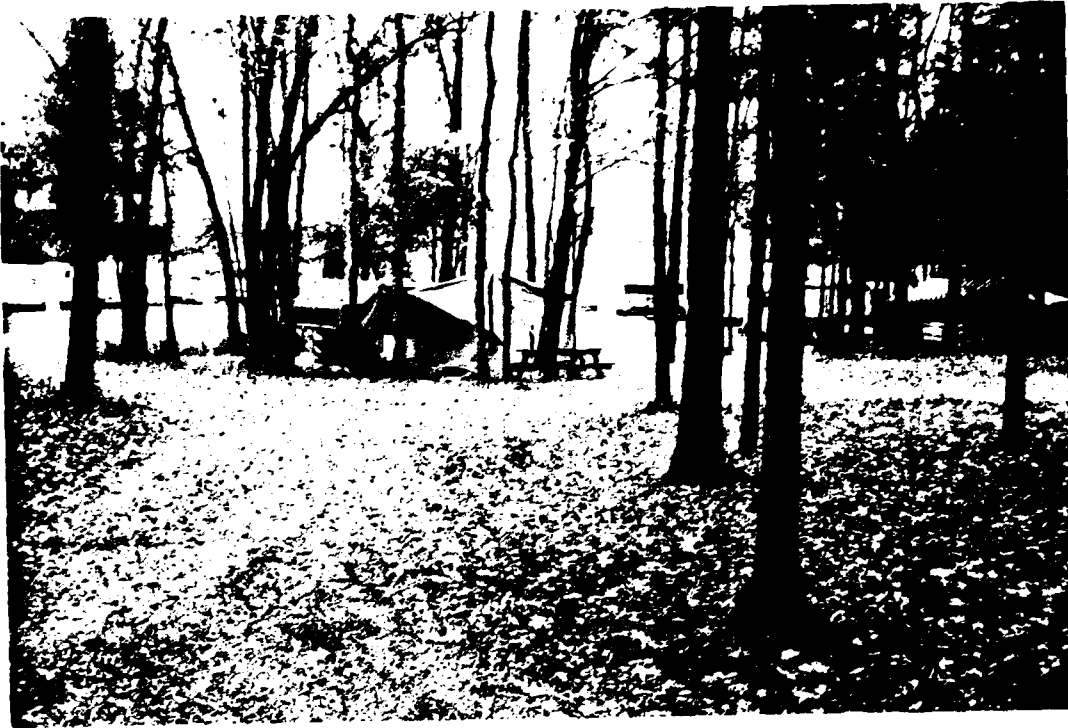
PHOTO 3. Campground with Spillway in Background

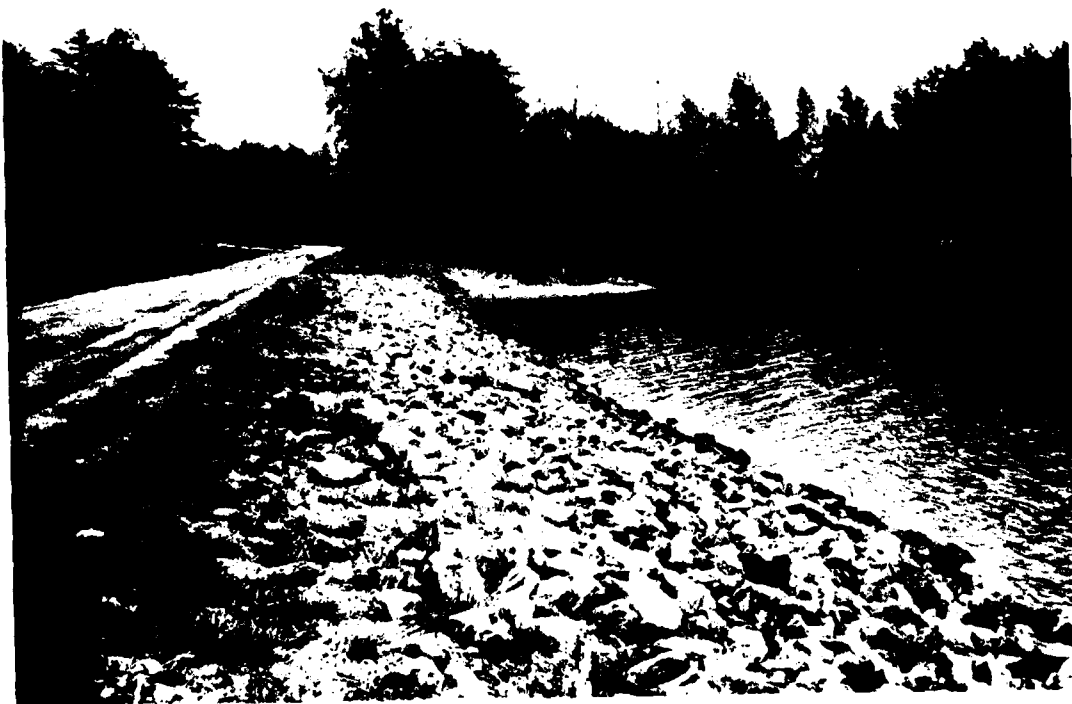
PHOTO 4. Right Abutment Area

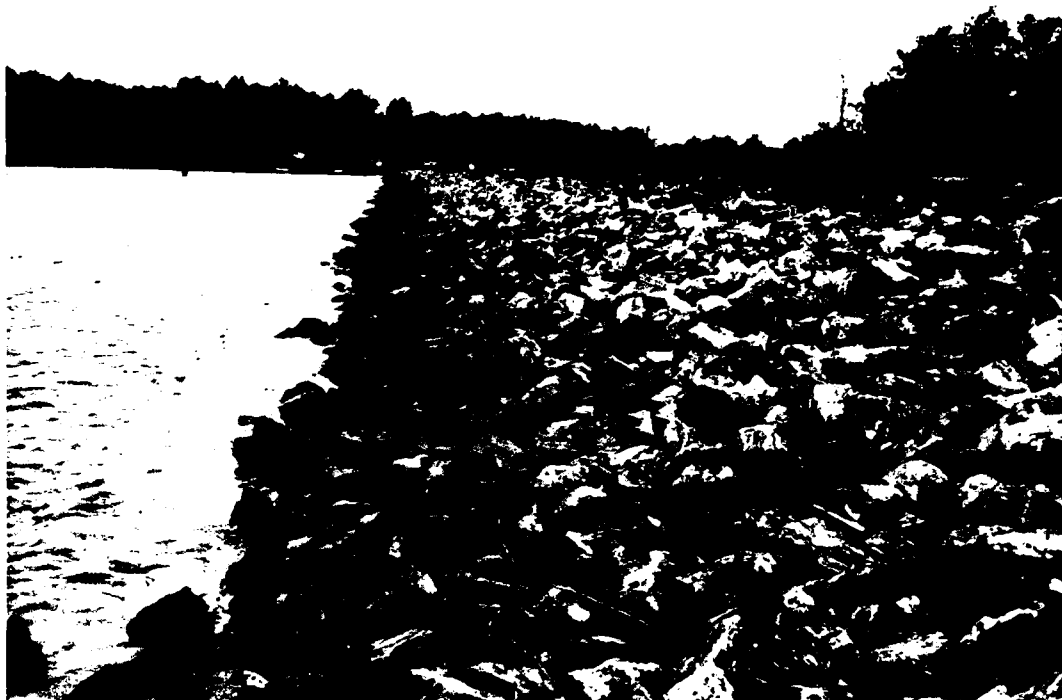
The support tower and stem for the emergency drain are badly corroded, unstable and may fail if operated. The outlet of the emergency drain is buried by material eroded from the embankment above.

PHOTO 5. Riprap on Upstream Embankment, Emergency Drain Control and Support in Left Background

VISUAL EXAMINATION OF	OBSERVATIONS	REMARKS OR RECOMMENDATIONS
EMERGENCY GATE	An emergency drain is located approximately 600 ft. from the left abutment. A gate valve hand control is located approximately 75 ft. off-shore. The gate valve supporting tower and mechanism are badly corroded and very unstable and may not operate.	The valve stem and support tower should be tested for operation and repaired with non-corrosive materials.

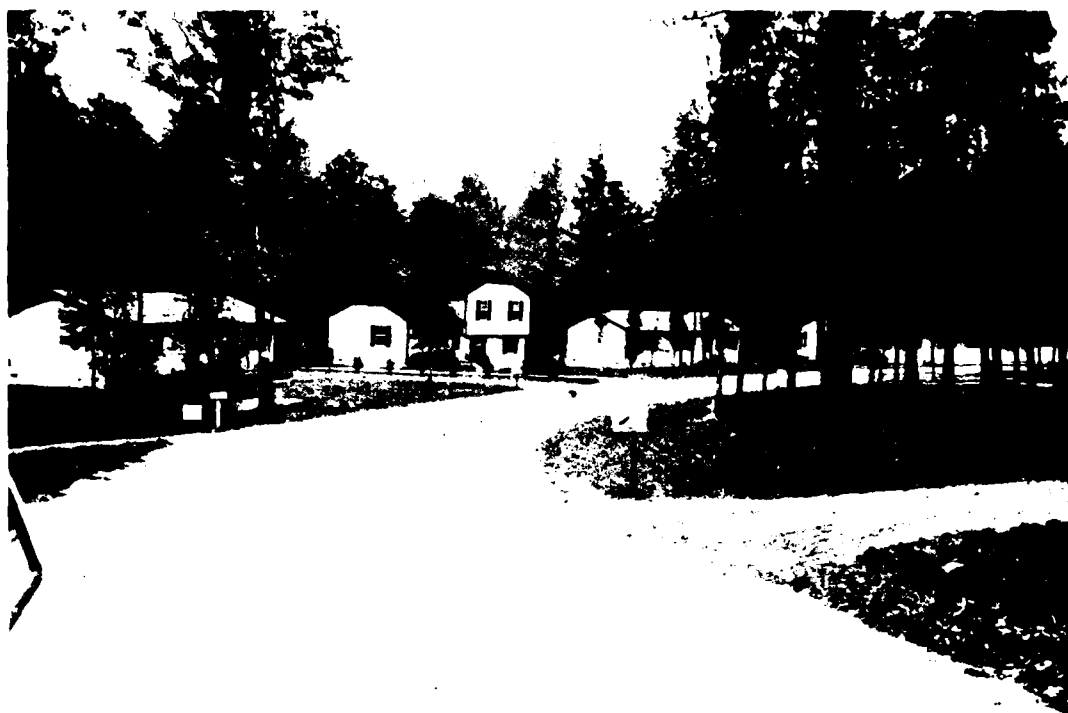
PHOTO 7. Houses Downstream of the Dam, in Plan on West Side of U. S. Route 1

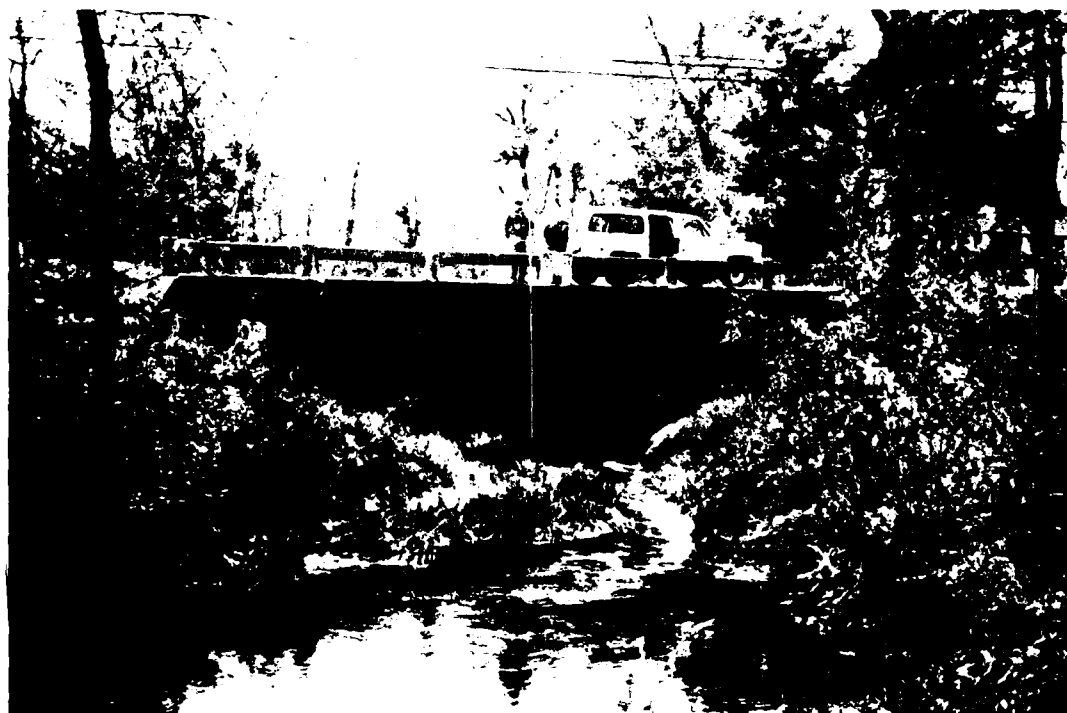
PHOTO 8. Bridge for U. S. Route 1, Downstream of Dam
